Route 101/154 (South) Interchange

Completed: August 1997

This project included the replacement of the existing Route 154 separation structure, widening of Calle Real to four lanes, constructing a new southbound on ramp and auxiliary lane to Route 101 and the installation of signals at four intersections. This project is located within both the City of Santa Barbara and the unincorporated area of Santa Barbara County.

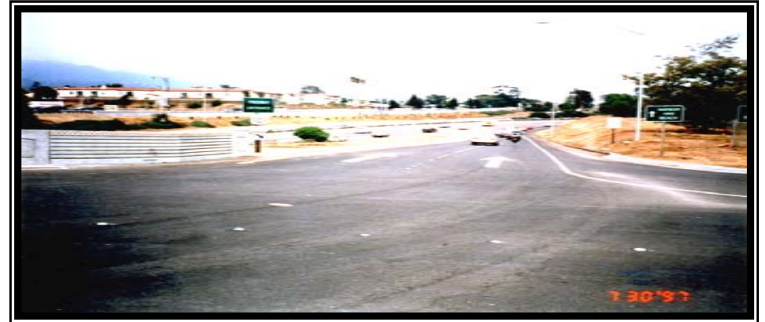
PHOTO 3: At San Antonio Creek Road, a new left-turn lane was constructed for westbound traffic. In order to accommodate this lane and the transition, the roadway was widened on the eastbound side. Excavation of a small hillside was required.
