Route 101/Betteravia Road Interchange

Completed: September 1997

This project included the replacement of the heavily used Betteravia Road overcrossing with a new structure, the realignment of two of the four freeway ramps to Route 101, the widening of the other two freeway ramps, and realignment of two frontage roads. The improvements increased the intersection separation and improved traffic circulation at this interchange.

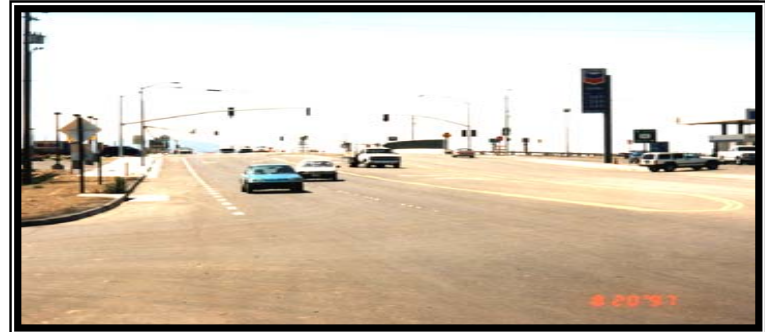
PHOTO 2: The intersection of Route 154, with San Marcos Road and Painted Cave Road was reconstructed to add left-turn lanes in both the eastbound and westbound directions. A substantial excavation operation, requiring removal of large boulders was undertaken. The slopes were constructed per the design to retain the natural look of the rock face.
