# Route 135/Betteravia Road Intersection

Completed: April 1995

This project included the improvement of a vital intersection within the City of Santa Maria. Route 135 (Broadway) is the primary north-south arterial and Betteravia Road provides access to Route 101, commercial shopping centers and the municipal airport. Two new right turn lanes were constructed, and three left turn lanes were lengthened.

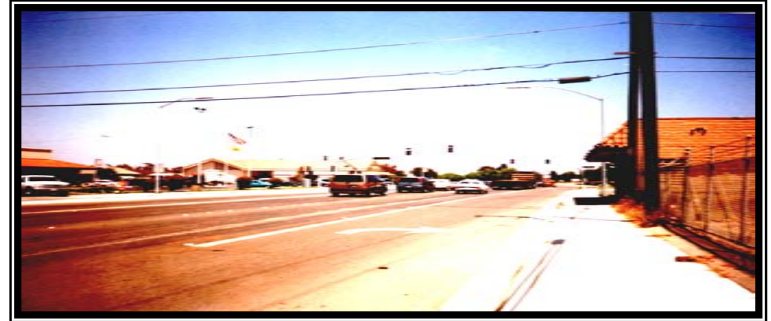
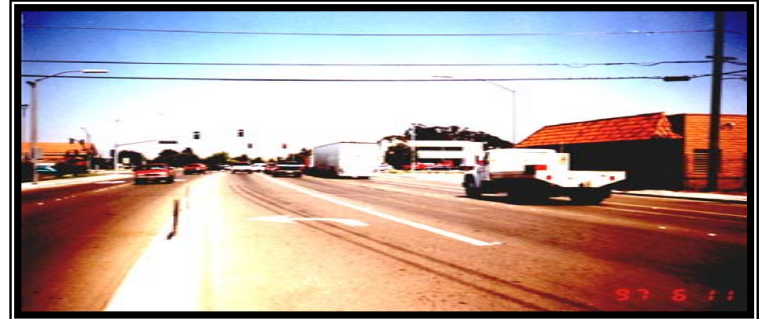
PHOTO 1 & 2: The west leg of the intersection was improved by adding a right turn lane for traffic heading to southbound Broadway. This improvement facilitates movements from the agricultural and business areas west of Broadway to areas in southern Santa Maria and Orcutt. In addition, the left turn lane was lengthened to provide more storage capacity.

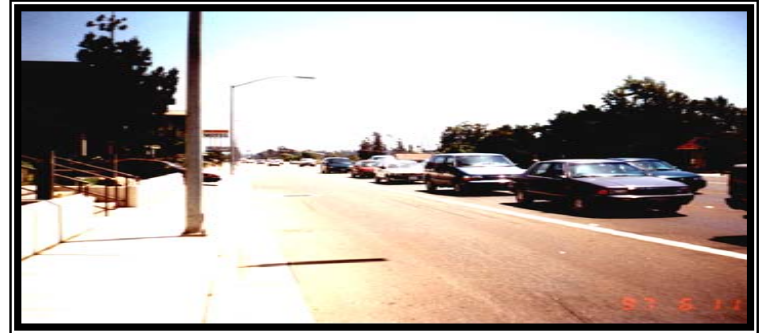
PHOTO 3: The south leg of the intersection was improved by adding a right turn lane for traffic traveling to eastbound Betteravia Road. This provides improved access to the government center, retail shopping and Route 101. A retaining wall was constructed to protect existing landscaping of the local businesses. The south leg was also improved by lengthening the left turn lane which provided additional storage capacity.
