Route 166 Operational Improvements

Completed: April 1995

This project included the improvement of a segment of Route 166 between the cities of Santa Maria and Guadalupe. In this area, Route 166 is an undivided two-lane, conventional highway. Improvements included the construction of left turn lanes at five intersections and shoulder widening throughout the project limits. Below is a list of some of the improvements.

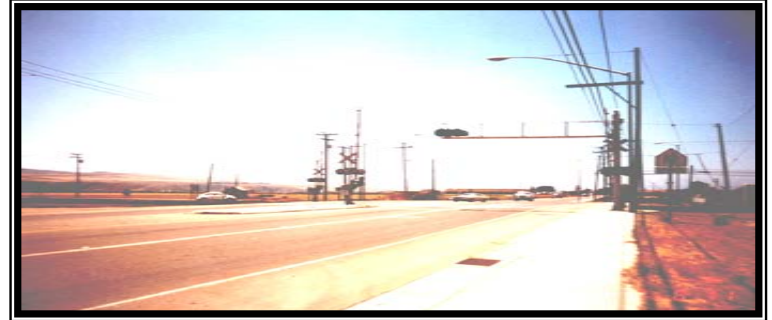
PHOTO 1: The western limit of this project included improvements to the intersection of Route 166 and Route 1. The entire intersection was rehabilitated, a new right turn lane for northbound traffic to Guadalupe was constructed, standard shoulders were constructed and the railroad grade crossing to the east of the intersection was improved. The improvements to the grade crossing consisted of track improvements, and new crossing arms to accommodate the increased width on Route 166.

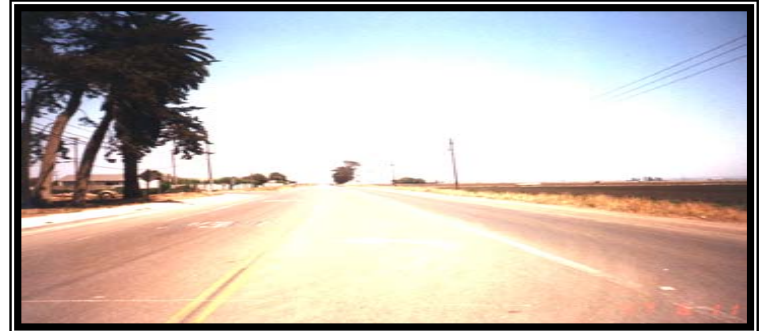
PHOTO 2: The intersection of Route 166 and Obispo Street (approximately 0.2 miles east of Route 1), was improved by adding a left lane for traffic turning north into Guadalupe. A sidewalk was constructed on the north side of Route 166 to accommodate pedestrian traffic. A majority of the pedestrian traffic consists of children traveling to and from school.

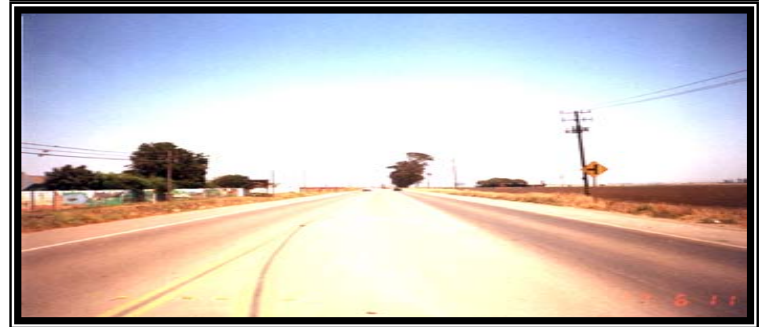
PHOTO 3: A left turn lane was constructed at Flower Street for eastbound traffic on Route 166. Again this intersection serves as an eastern access point into Guadalupe. Also, in this location, a drainage crossover was constructed in this area to shift the flow agricultural runoff from the northside of the project to the south.
